CHANGING OF VEGETATION ON GREEN ROOF

Zuzana Poórová¹, Zuzana Vranayová²

¹Technical University of Košice, Faculty of Civil Engineering, Vysokoškolská 4, Košice 04200, zuzana.poorova@tuke.sk, Slovakia

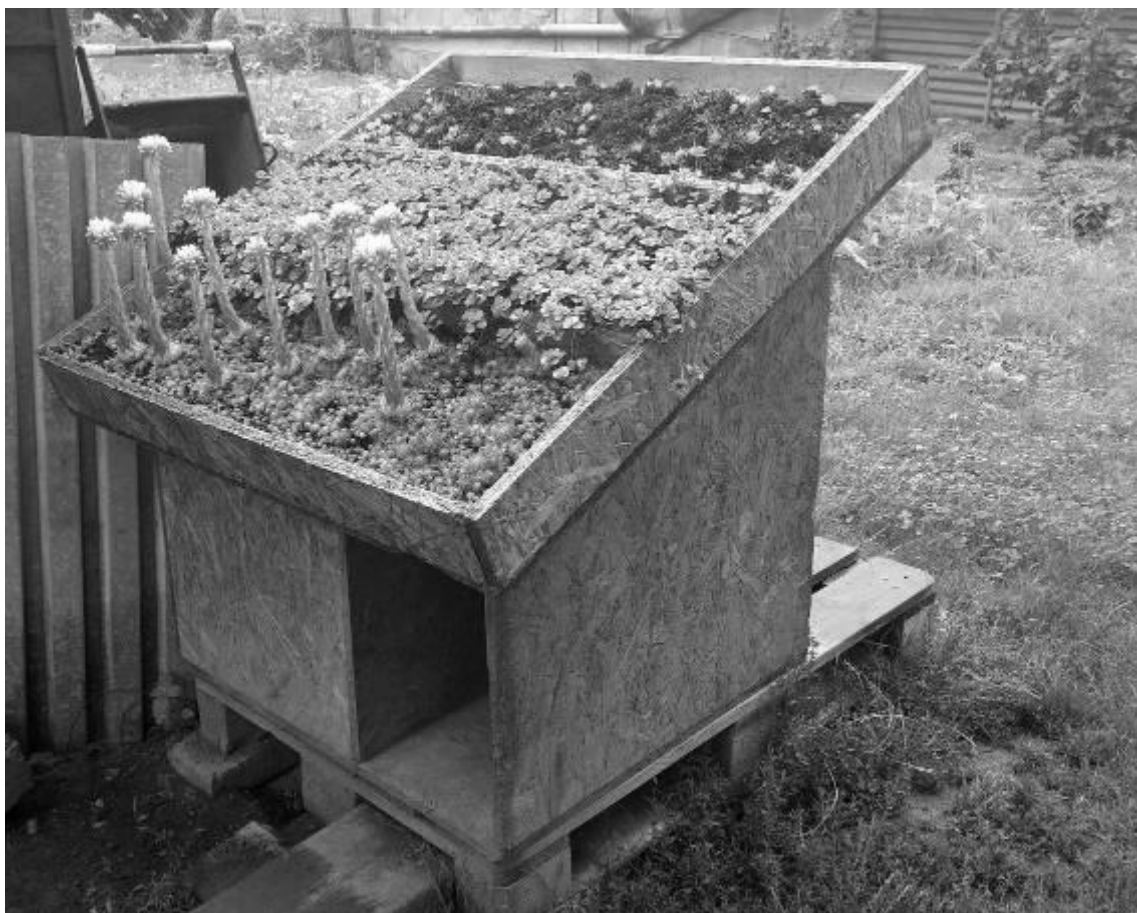
Figure 1: Doghouse and its green roof (source: author)

The truth is that for most of us, all this may seem very idealistic. To put a garden on our garage. Why not. But this is where it should start. Lots of joy, beautiful gardens, small domestic green roofs or sheds, garden offices, studios, bicycle sheds and other small structures. This article is about installing, constructing and planting a green roof on a little doghouse (Fig. 1), an opportunity to bring nature back to a place where it has been.

The doghouse disposition: vestibule and the dog’s room. The construction consists of floor, five walls and the roof. Entry to the dog’s room is inside the doghouse from the vestibule, under the roof. The roof is aisle with 22° slope. Floor dimension is 800x800 mm. Roof dimension is 1000x1000 mm. The roof is overhanging 100 mm the floor on each side. Height of the wall with the entrance is 450 mm, opposite wall height is 750 mm. Signature element of this roof is horizontal division into three parts. The division has aesthetical reasons but main reason of avoiding soil slide. There are holes in the construction bottom parts dividing the roof into three parts. These holes are ensuring water runoff during storm rainfall. Construction of the doghouse is made of 15 mm thick OSB boards. The dog’s room is insulated with thermal insulation. Construction of the roof is described in Tab. 1. Change of vegetation between January 2016 and August 2016 can be seen on Figures 3-6.

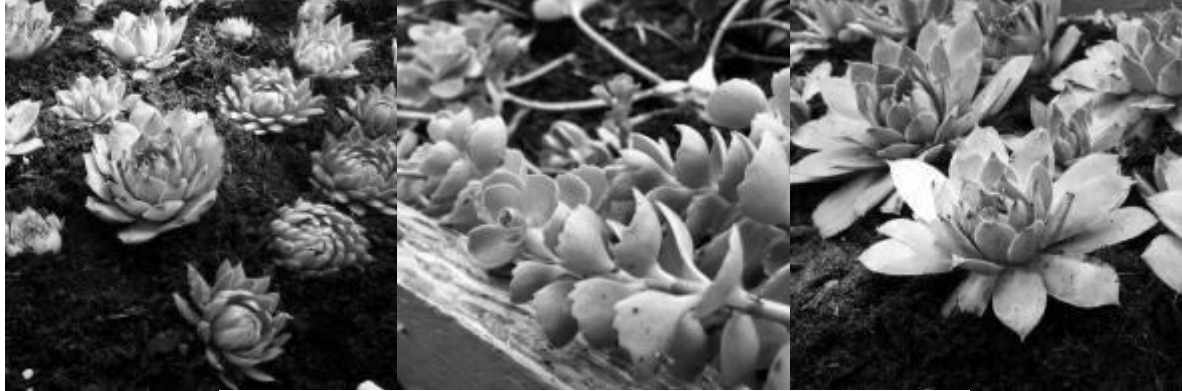
Sempervivum Jovibarba allionii (left), Sempervivum Tectorum (middle) and Sedum Spurium (right) (Fig. 2) were used because of two main reasons. Economical reason: all used plants were taken directly from nature, meaning cheap version of having plants for free. Low/ no maintenance reason: used plants need low/ no maintenance and no irrigation.

Figure 2: Sedums used on the green roof (source: author)

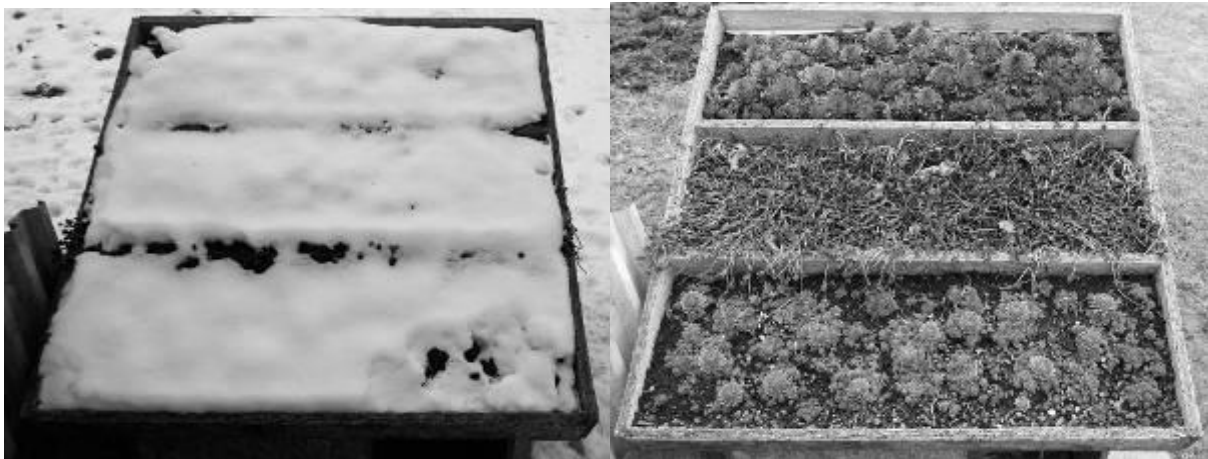
Figure 3: Doghouse in 01/2016, 02/2016 (source: author)

The main idea of this article was to show the change of vegetation in time. *Sempervivum Jovibarba allionii* showed the biggest change in terms of growing and blooming flowers. *Sempervivum Tectorum* was changing in February, the leaves started to grow and get bigger, but there was no significant change. *Sedum Spurium* was the only sedum type that did not survive this period of time. Few flowers of this type remained in sedum, the research will continue and the green roof will be observed.

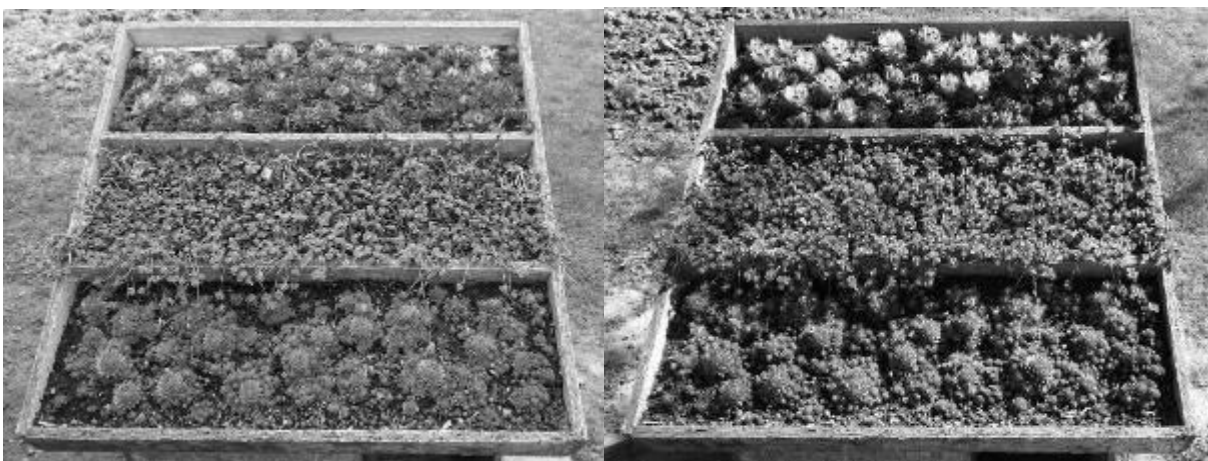
Figure 4: Doghouse in 03/2016, 04/2016 (source: author)

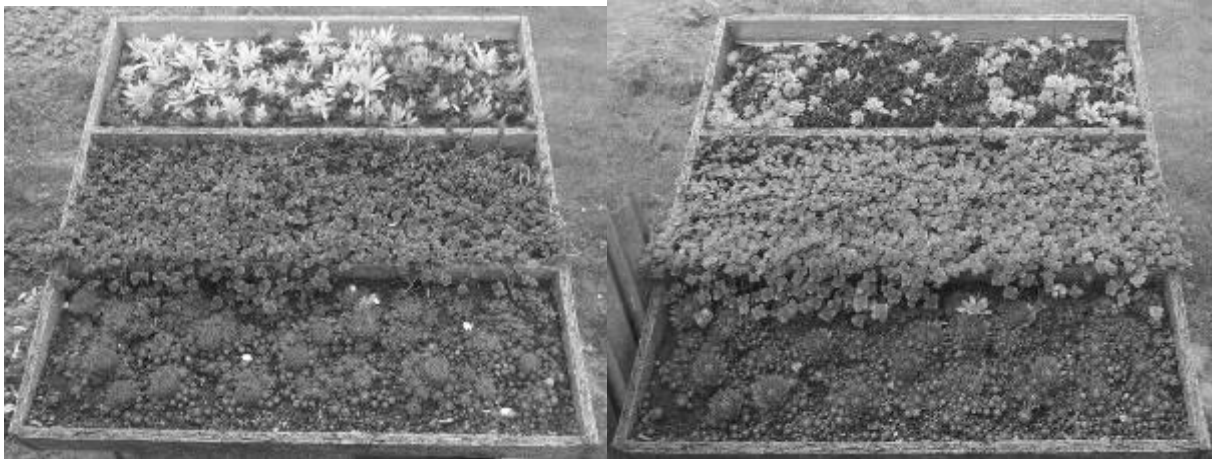
Figure 5: Doghouse in 05/2016, 06/2016 (source: author)

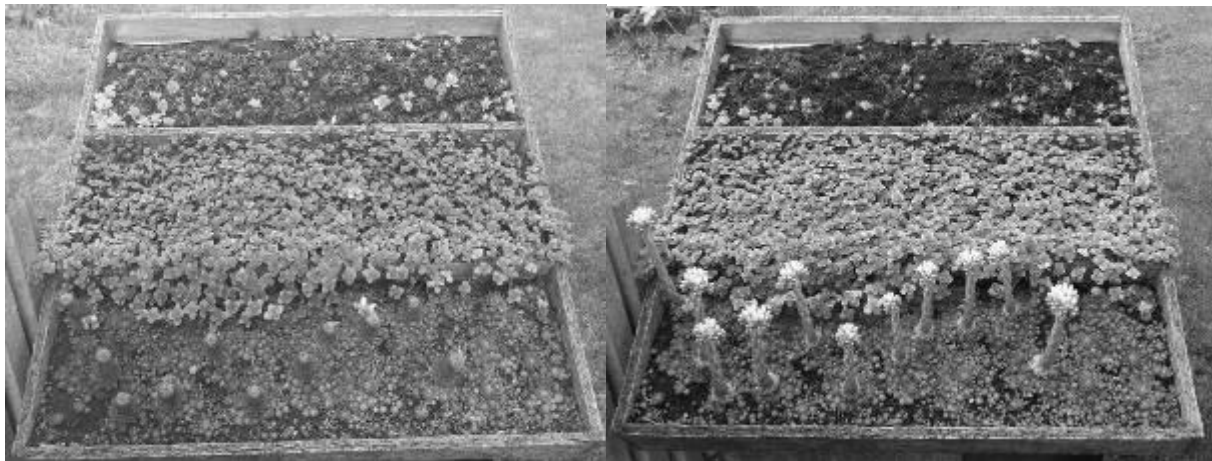
Figure 6: Doghouse in 07/2016, 08/2016 (source: author)

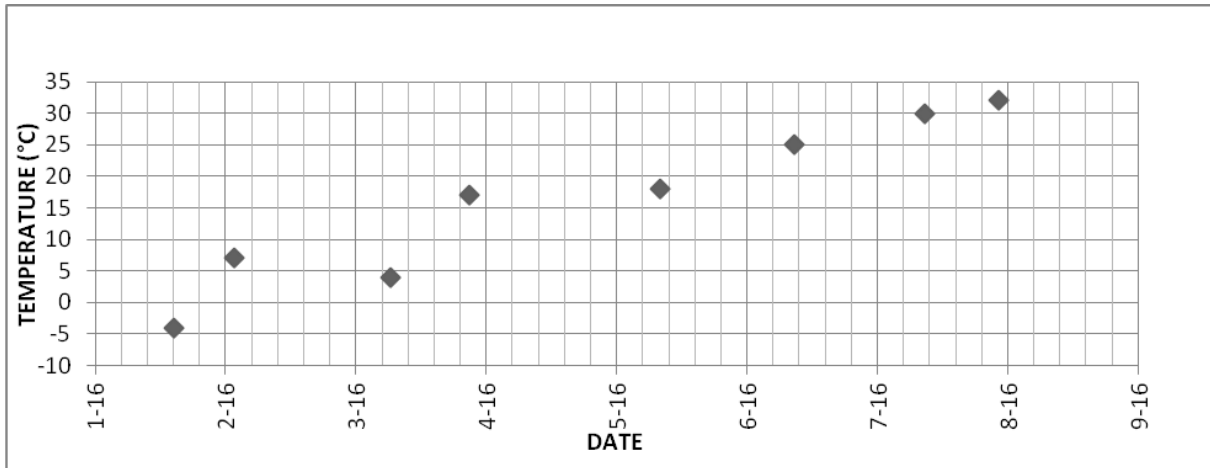
Figure 7: Maximum day temperatures

Weather was observed between January 2016 and August 2016. Every month in approximately 30 days interval. Maximum high temperature (°C) (Fig. 8), minimum low temperature (°C) (Fig. 9), rain precipitation (mm) (Fig. 10), snow precipitation (cm) (Fig. 11) and humidity (%) (Fig. 12) were monitored using www.accuweather.com data. All monitored data can be found in Table 2 and the changes of the data can be seen in Figures 7-11.

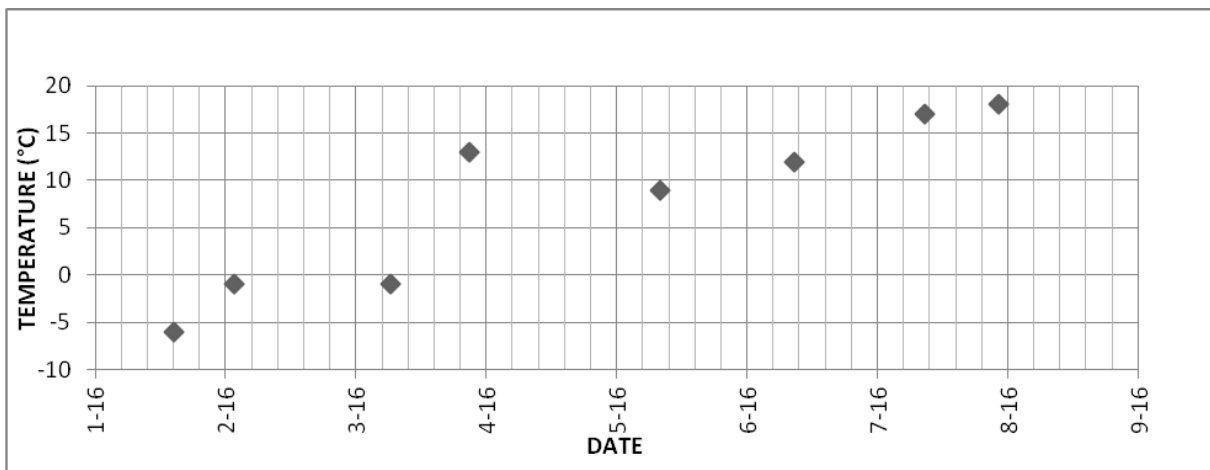
Figure 8: Minimum day temperatures

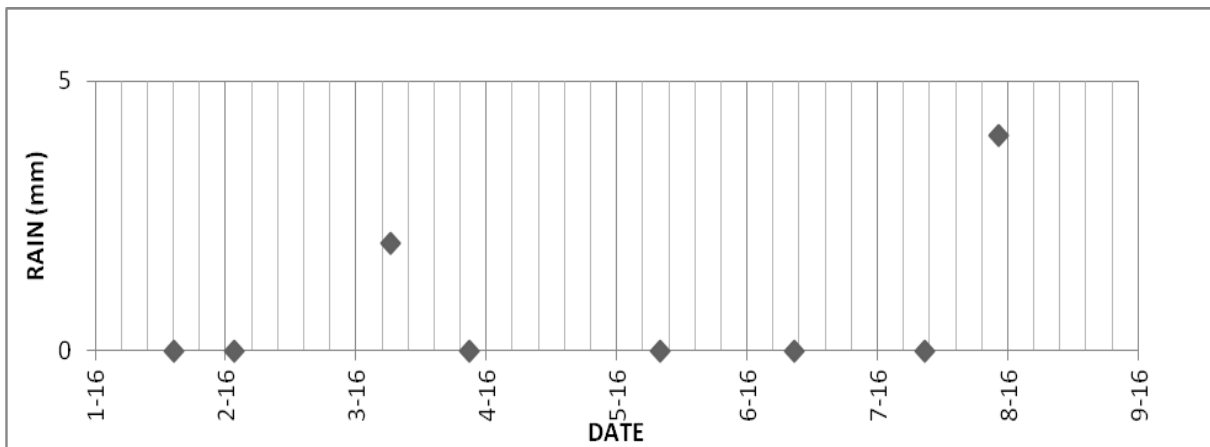
Figure 9: Rain precipitation

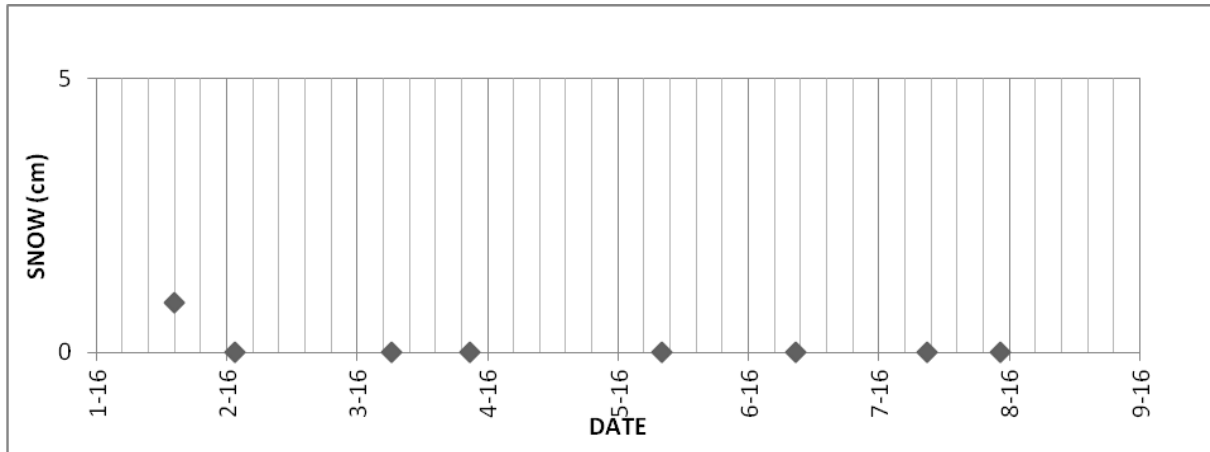
Figure 10: Snow precipitation

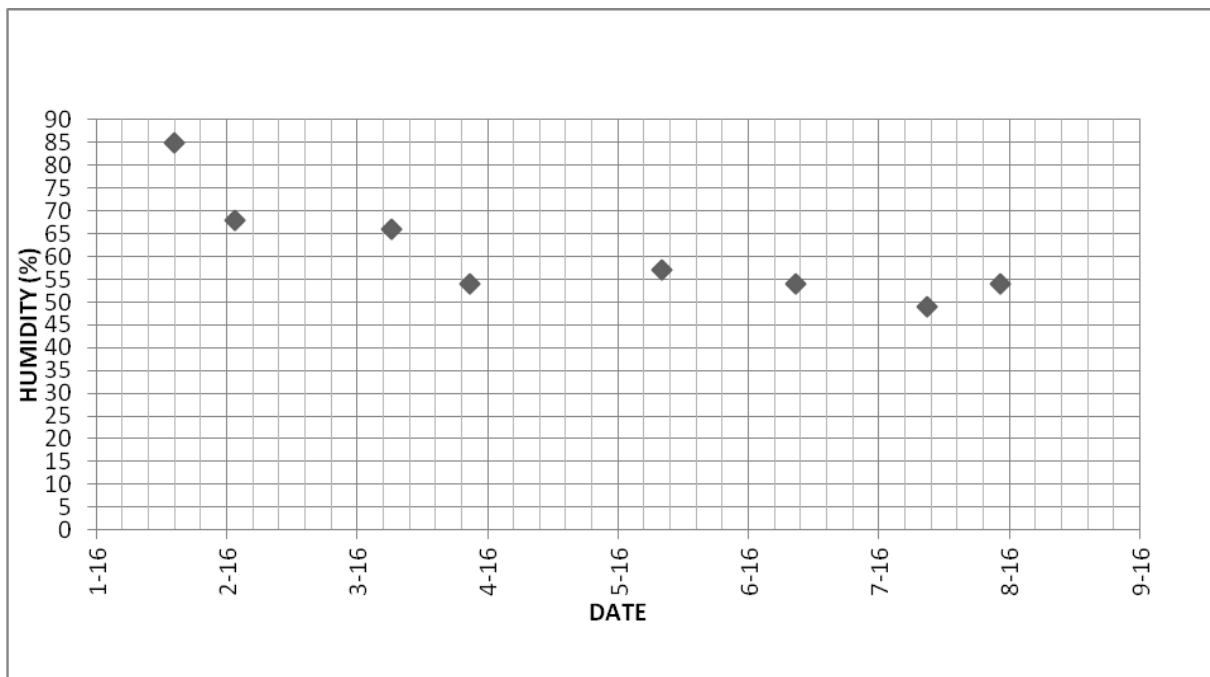
Figure 11: Humidity
